# **CANADIAN FORCES FLIGHT SAFETY INVESTIGATION REPORT (FSIR)**

## **FINAL REPORT**

**FILE NUMBER:** 1010-188732 (DFS 2-2-2)

**AIRCRAFT TYPE:** CF188 - Hornet

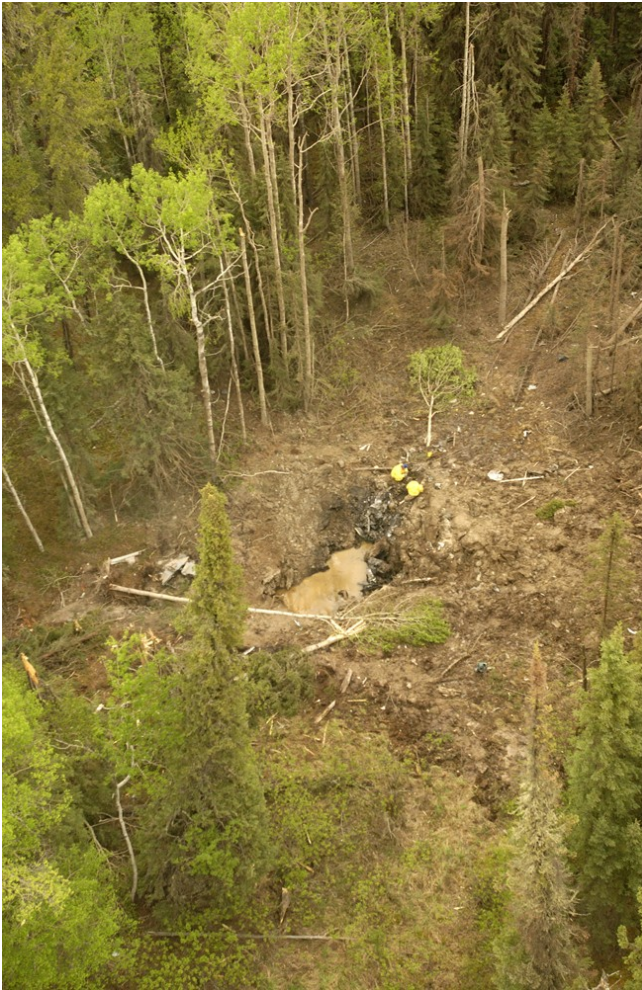
The wreckage area was quite large, approximately 1500 feet long and 500 feet wide. Using inclinometers, ACMI data, the tree damage pattern and ground scars it is estimated the aircraft hit the ground roughly inverted at 432 KIAS, 26 degrees nose down, and 148 degrees right bank. A crater 20 feet wide, 30 feet long and 15 feet deep was created. Most of the upper half of the fuselage wreckage pieces, including the engines and gun, were buried in the crater.

Fig 1. Impact crater

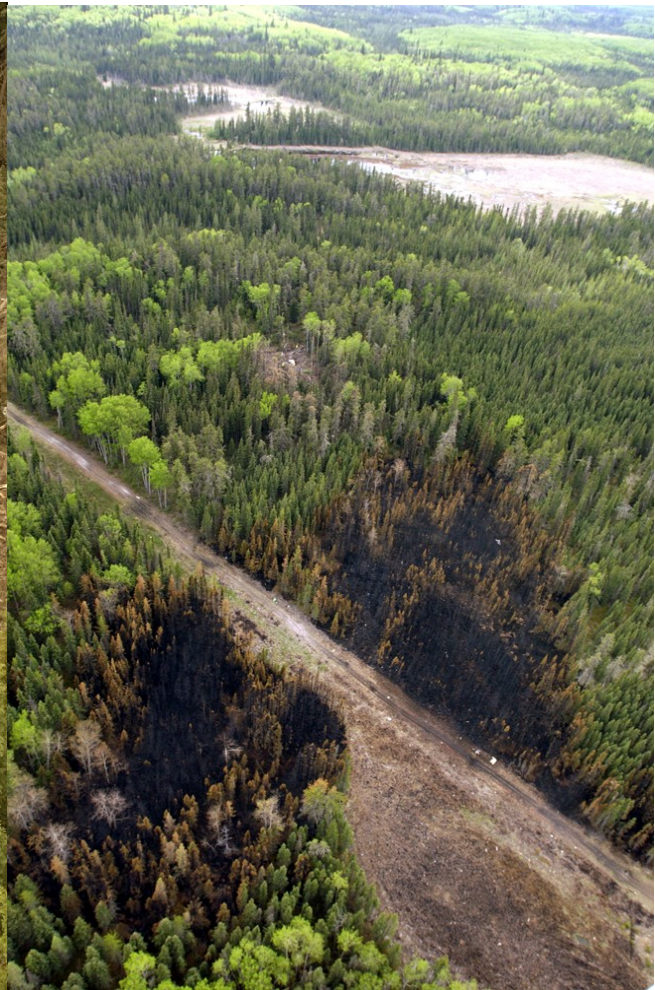
The aircraft sustained “A” category damage when it impacted the ground. Ground impact forces completely fragmented the airframe with the resulting debris field measuring 1500 feet long and up to 500 feet wide. Within a few hours of ground impact a forest fire started in the debris field. This fire burned for the next four days, causing further damage to many aircraft components within the fire area. The ensuing fire fighting efforts caused some additional damage and may have removed some evidence. These latter events only affected debris in the fire area. See Figures 1 to 3 of Annex A.

Fig 2. Impact area

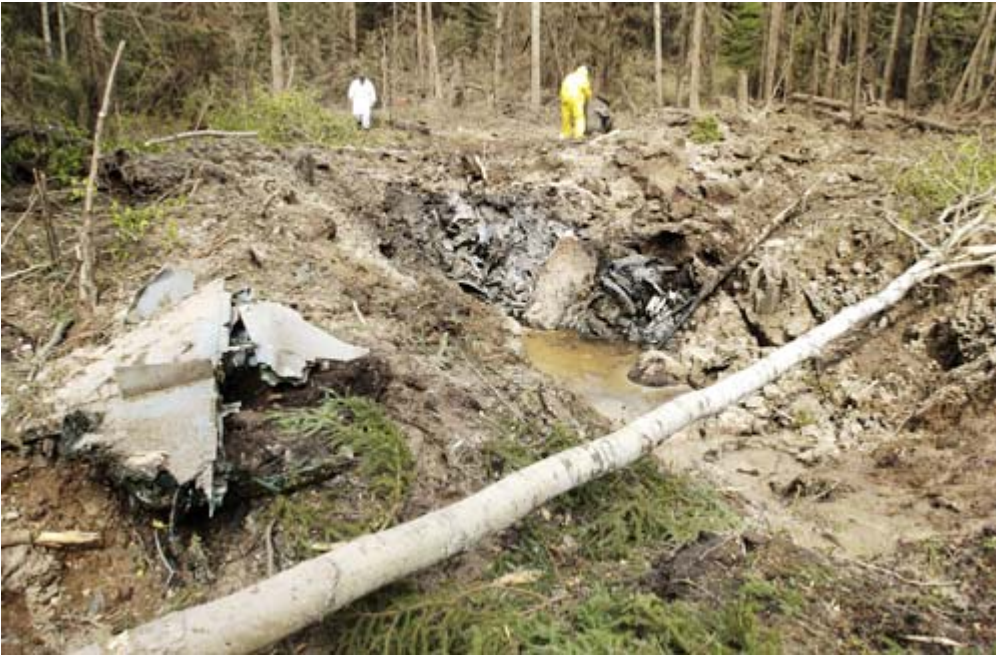
Fig 3. Impact crater close-up

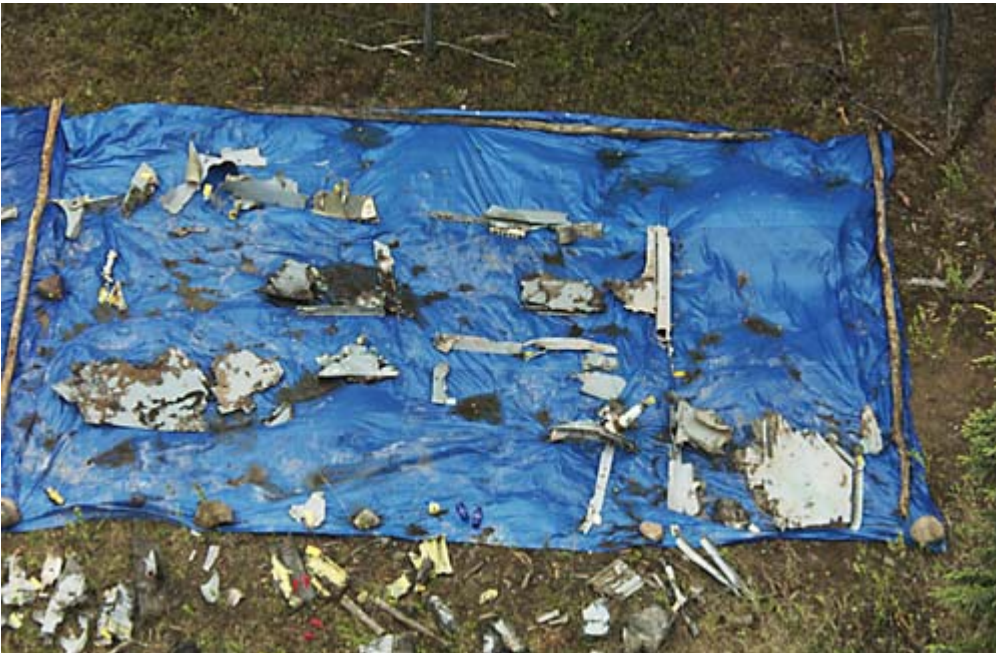
Fig 4. Some of the flight control parts recovered

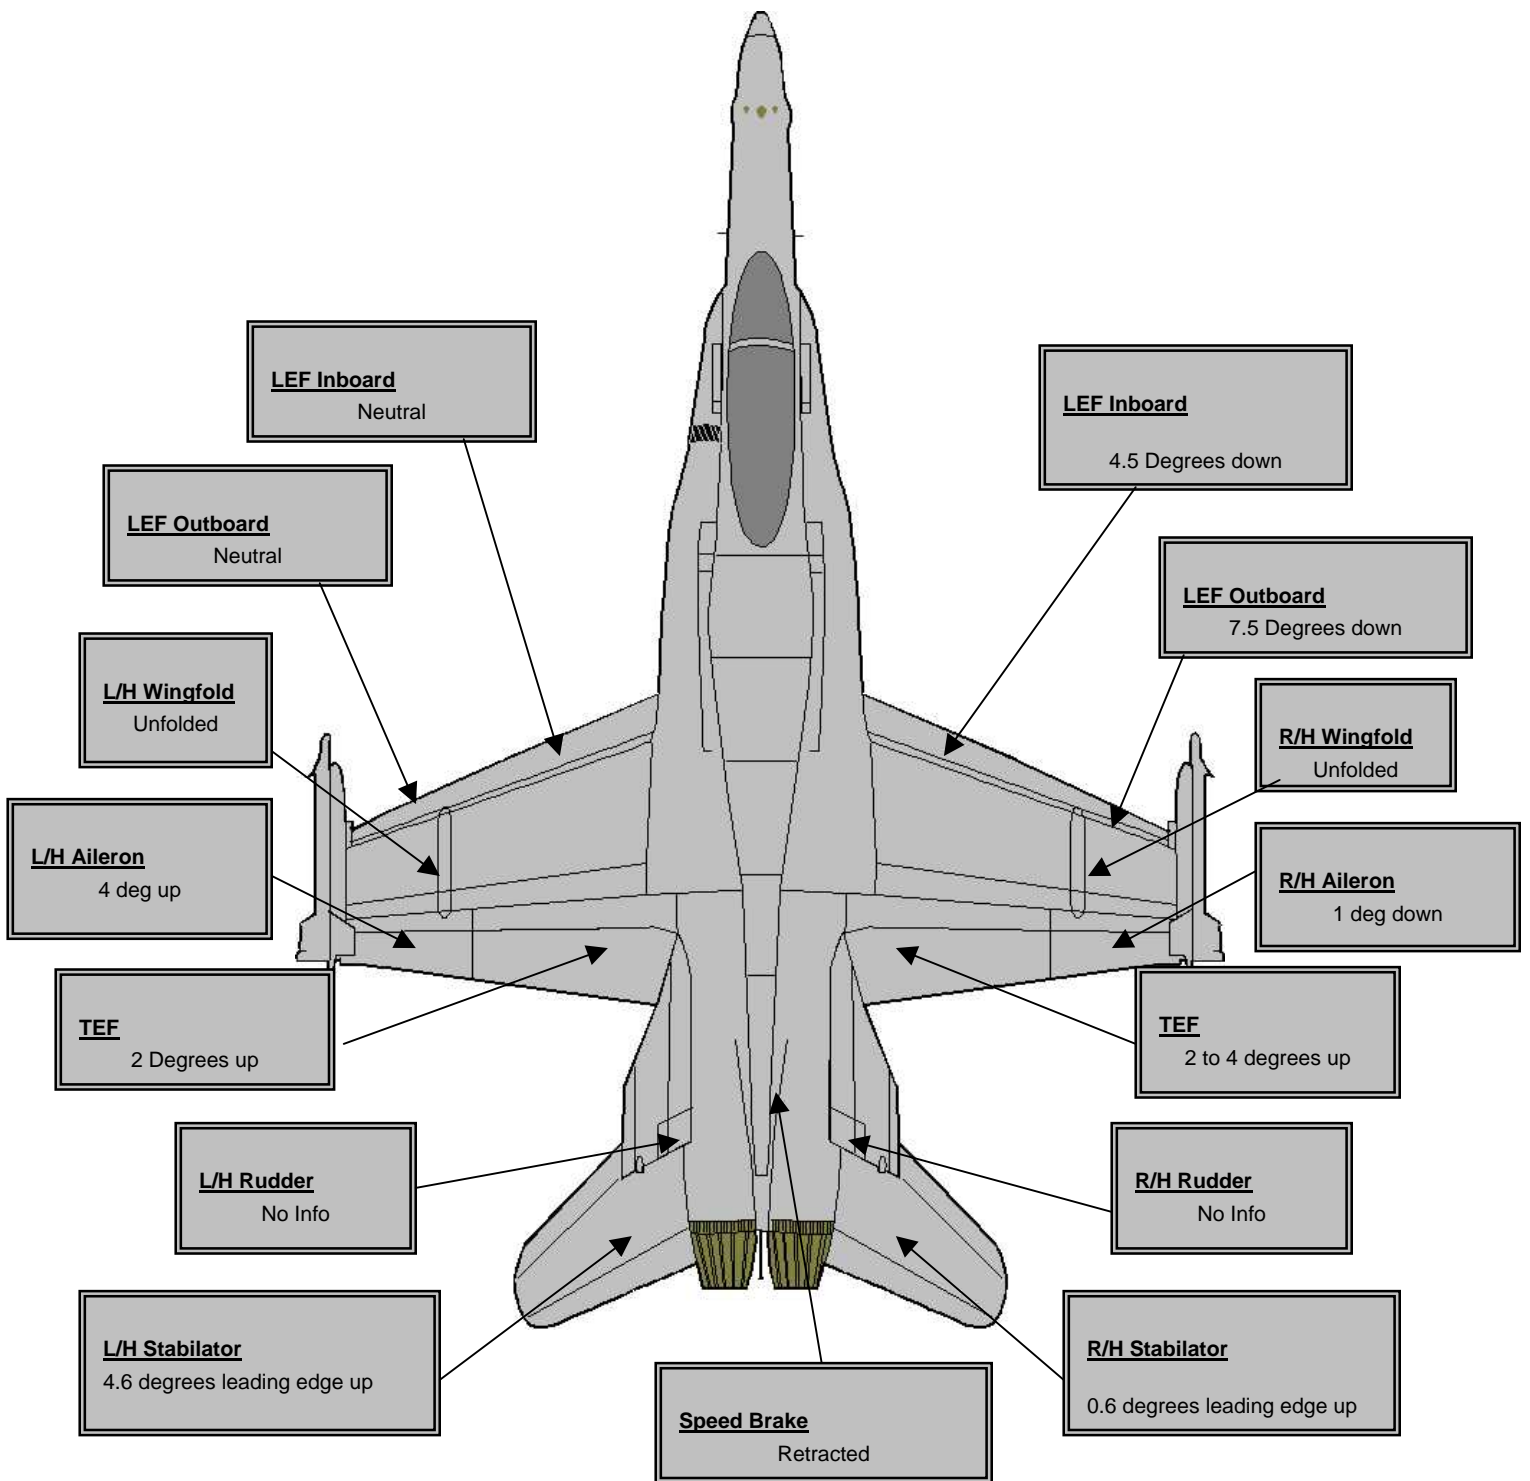
Fig 5. Flight control deflections at time of impact

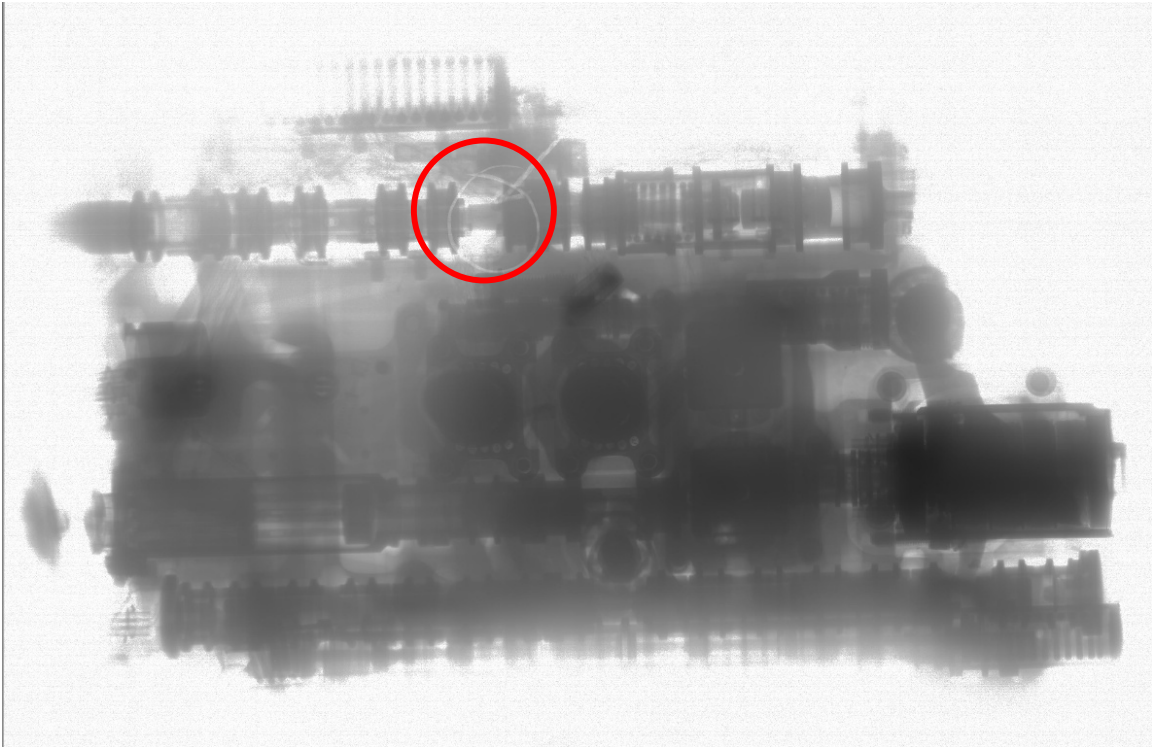
Disassembly showed that the MSV sleeve had fractured which allowed a portion of the sleeve to move to the left. It is most probable that impact forces resulted in

the fracture. Examination of the spool showed an impact mark on its surface, created by the sharp edge of the fractured sleeve.

The position of this mark defines the relationship of the MSV spool and the sleeve at the moment of impact, and is the position corresponding to CAS mode. The sleeve is held in position within the valve body by a shoulder on the right hand end, thus after the fracture, the right piece of the sleeve was still in its correct position. The broken-off left piece of the sleeve was free to move in its bore in the valve body, and as was evident in the post crash radiograph, had moved to the left (i.e. forward with respect to the aircraft's longitudinal axis) under the impact forces.

Fig 7. Radiograph of right stabilator actuator. Mode select valve spool fracture is highlighted in red circle.

Fig 8. Disassembled MSV with close-up of spool fracture.

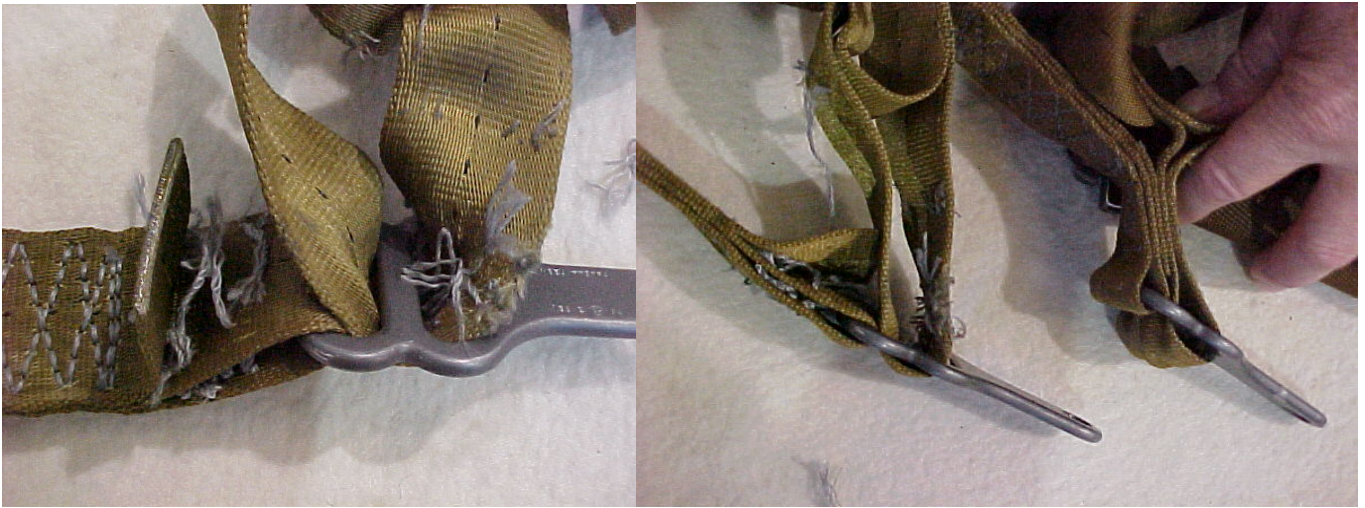
Fig 9, 10. Broken stitching, left lower harness lock; comparison with serviceable lock.

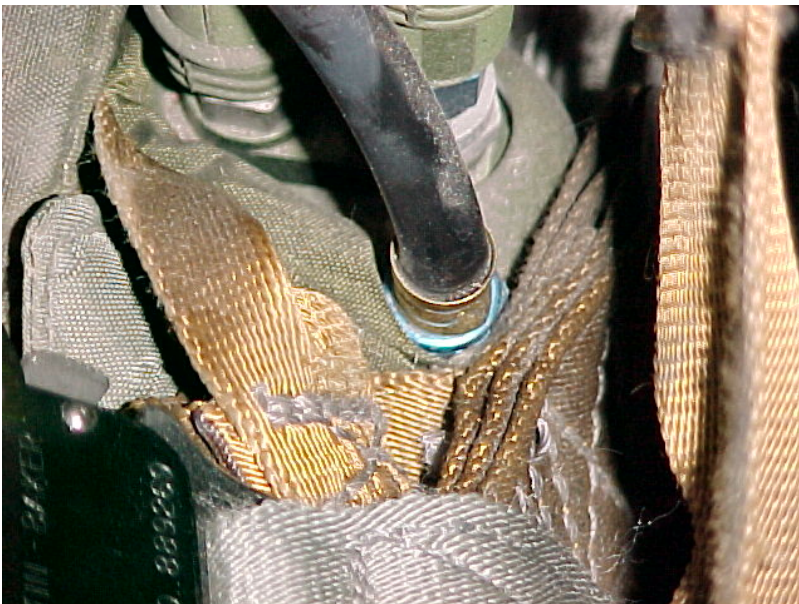
Fig 11. Oxygen attachment pipe nut location vs. lower harness lock stitching.

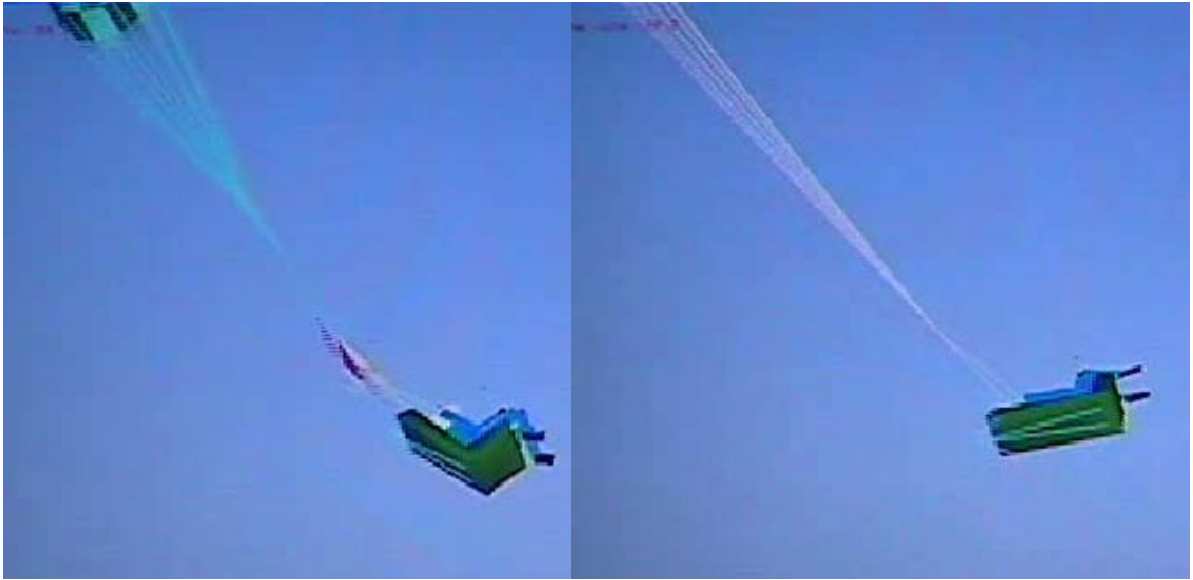
Fig 12,13. Extraction of main parachute by drogue chute; approximation of misalignment of seat/pilot with main chute axis on inflation.
